Manhole Inspection Summary

Manhole # S67U__016MH

Record Plat: **67U** Node: **016** Status: **Other (Specify in comment)** Insp Date: **3/13/08 2:09 PM**

Location Address: **1700 Charlotte Ave.**

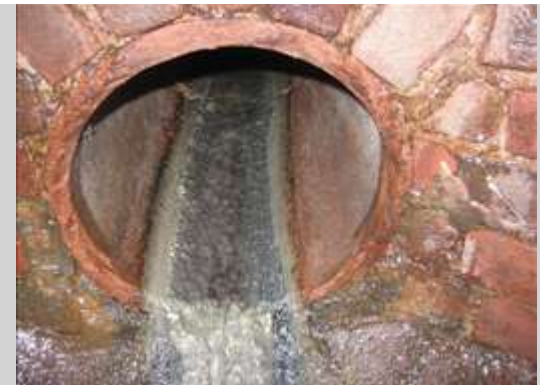
3 O'Clock Inflow

12 in. Circular Gravity Sewer
Pipe In @ 3 O'Clock

Pipe Height: **12** (in.) Rod and Bar (Angled)
Pipe Material: **Clay** ☐ Pipe Lined
Invert Depth: **8.83** (ft.) Flow Characteristics: **Fast**
Deposits: ☒ None ☐ Mud ☐ Sludge ☐ Debris ☐ Grease
Silt Depth: (in.) Deposits Extent:
Infiltration: **None** Pipe Seal Cond: **Sound**
